TWR-17542 Vol IV
Rev. A

FLIGHT SET 360L003 (STS-29)
SEALS FINAL REPORT
Volume IV

July 1989

***Thiokol* CORPORATION**
SPACE OPERATIONS

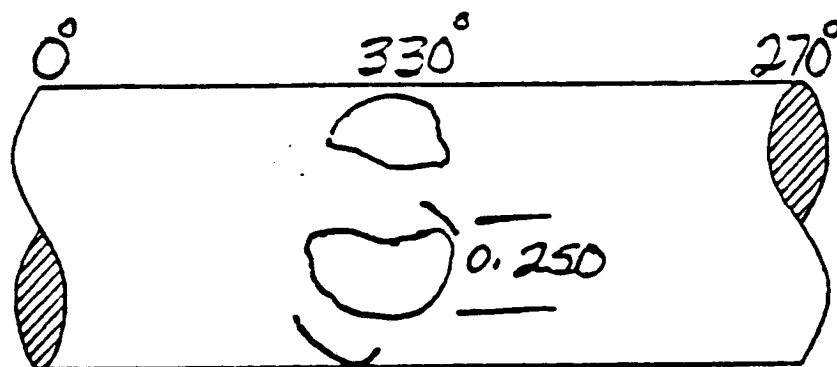
Figure 11
Wiper O-ring Damage From Left Nozzle-to-Case Joint

$$\begin{aligned} L &= 0.250 \\ W &= 0.180 \\ D &= 0.040 \end{aligned}$$

There were no signs of O-ring damage at the time of disassembly on the primary, secondary, or wiper O-rings. Detailed inspection of the O-rings found no damage to the primary or secondary O-rings. The wiper has a radial gouge at 158 degrees that is 0.080 inch long by 0.025 inch wide by 0.010 inch deep. Inspection of the Stat-O-Seals found three that had open flow lines, the longest being 0.4 inch long. Fifteen stat-o-seals were found with closed flow lines, two that had excessive grinding on the I.D. of the seal, and one that had a blister on the I.D. of the seal.
